Cornell University
Laboratory for Elementary-Particle Physics

Experimentally Observed Defects in Niobium SCRF Cavities Tested at Cornell

Zachary A. Conway

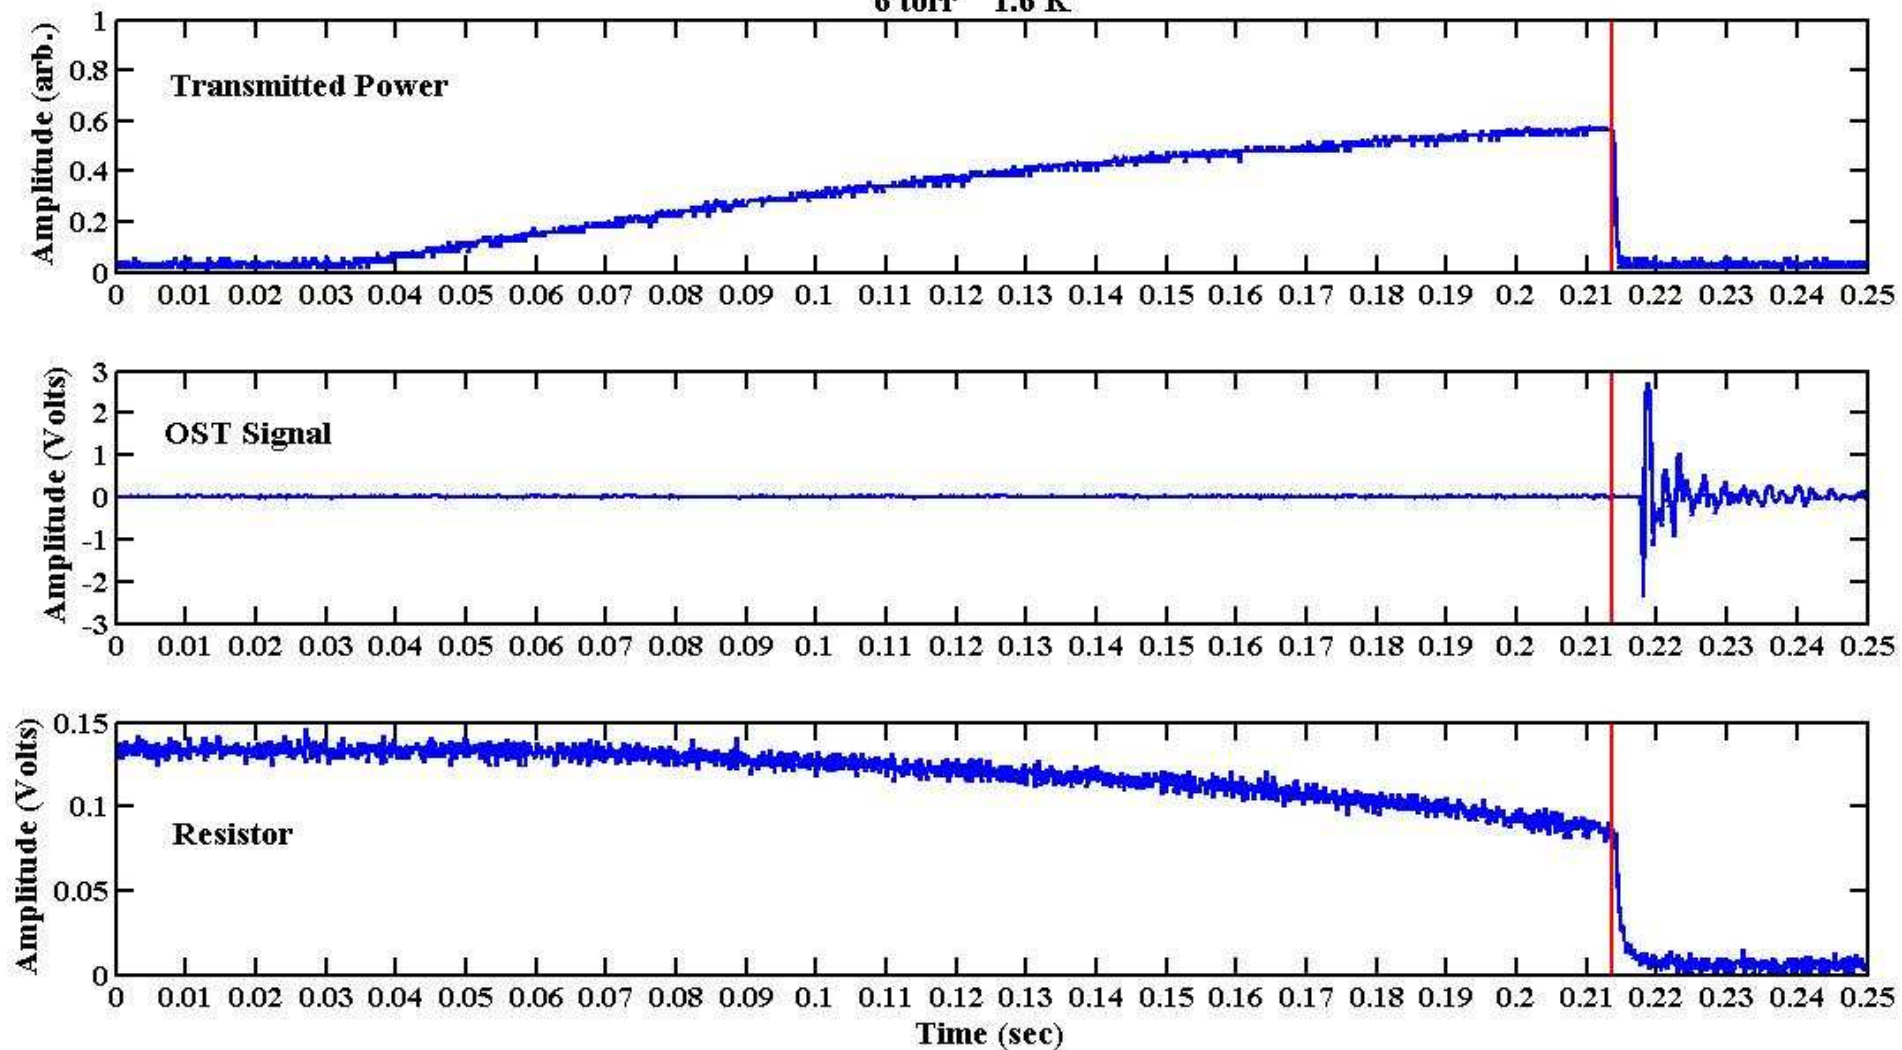
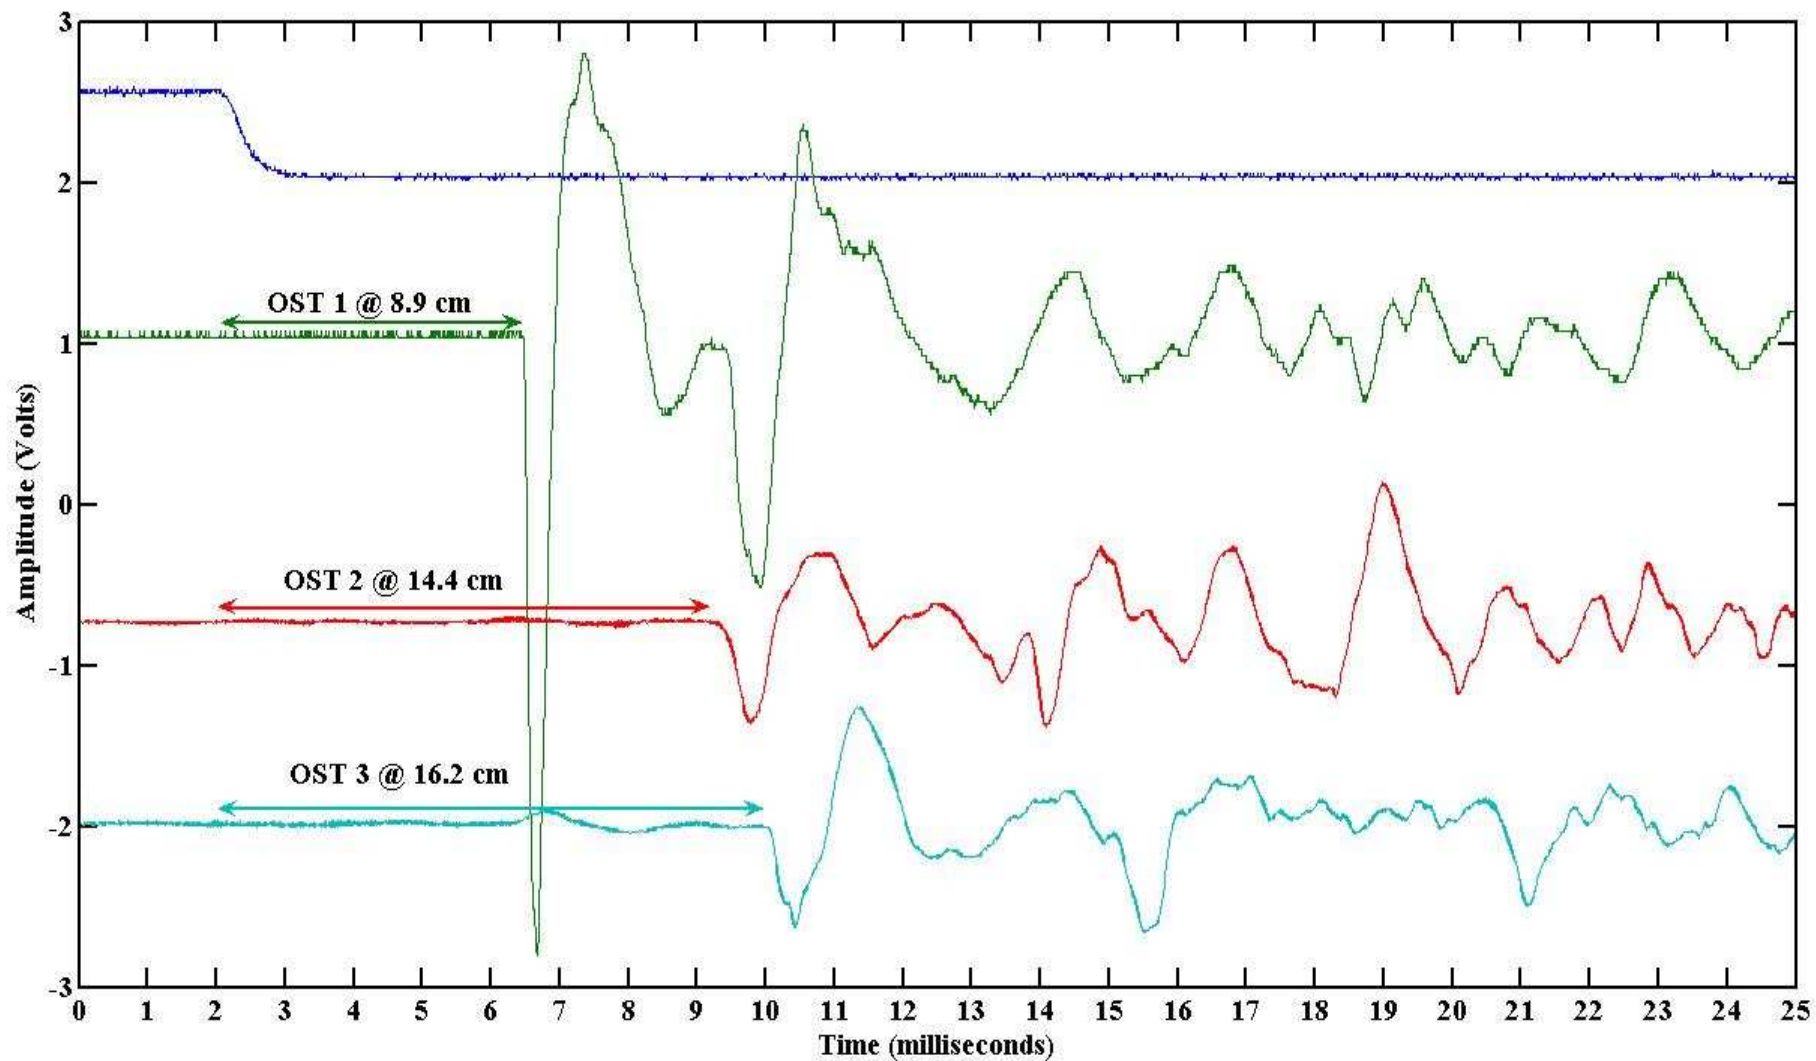
Thermometer 22 Event

- Simple defect localization schemes can be implemented by exploiting the properties of superfluid He, e.g. second sound waves.
- When a cavity quenches, typically several joules of thermal energy are transferred to the helium bath in a few microsecond.
- If the cavity is operated at $T < 2.17\text{K}$, the helium bath is a superfluid and a second sound wave propagates away from the heated region of the cavity.
- By locating several transducers in the helium bath around the cavity, the second sound wave front can be observed. The time of arrival of the second sound wave at a given transducer is determined by the time of flight from the heated region, which is centered on the defect causing quench.
- Measuring the time of flight to 3 or more uniquely located transducers, unambiguously determines the defect location.

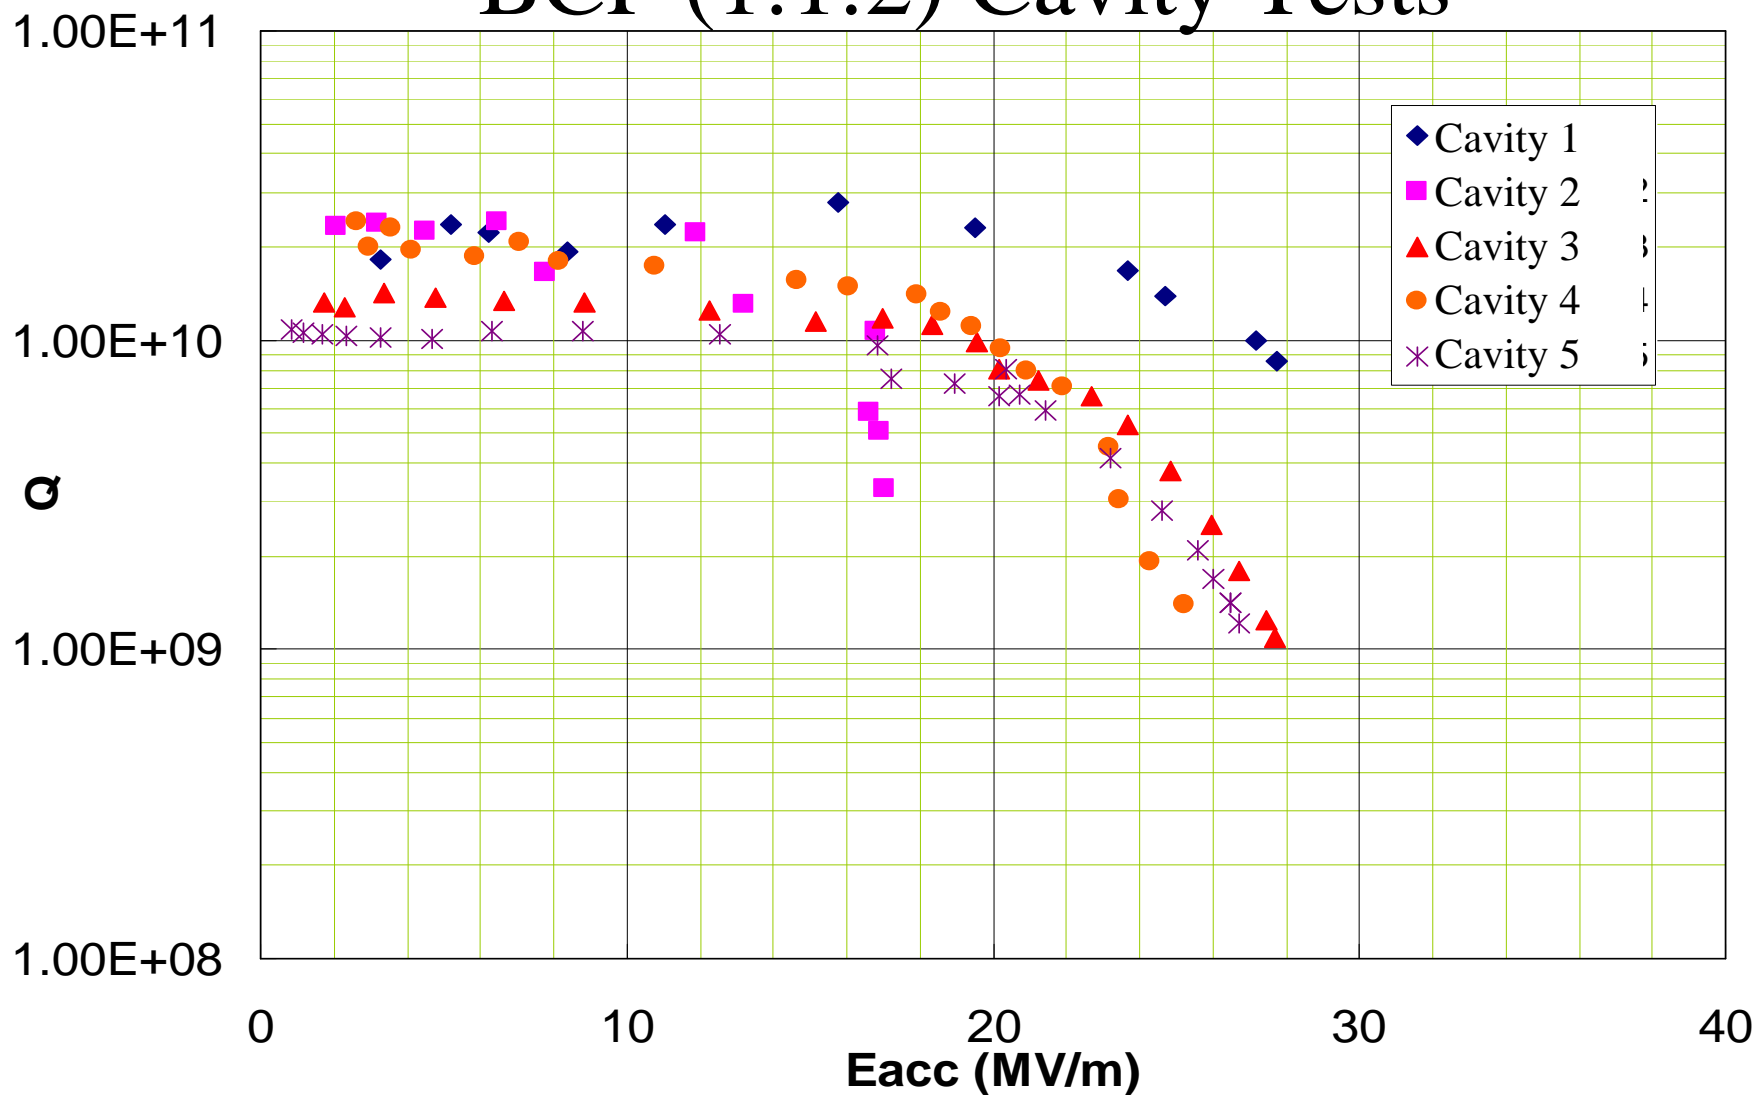
BCP (1:1:2) Cavity Tests

- In the past 1.5 years we have tested 15 distinct cavities from three different fabricators.
 - 12 TESLA style single cell cavities.
 - 1 re-entrant single cell cavity
 - 1 re-entrant 9-cell cavity
 - 1 9-cell ILC type cavity
- Test Results:

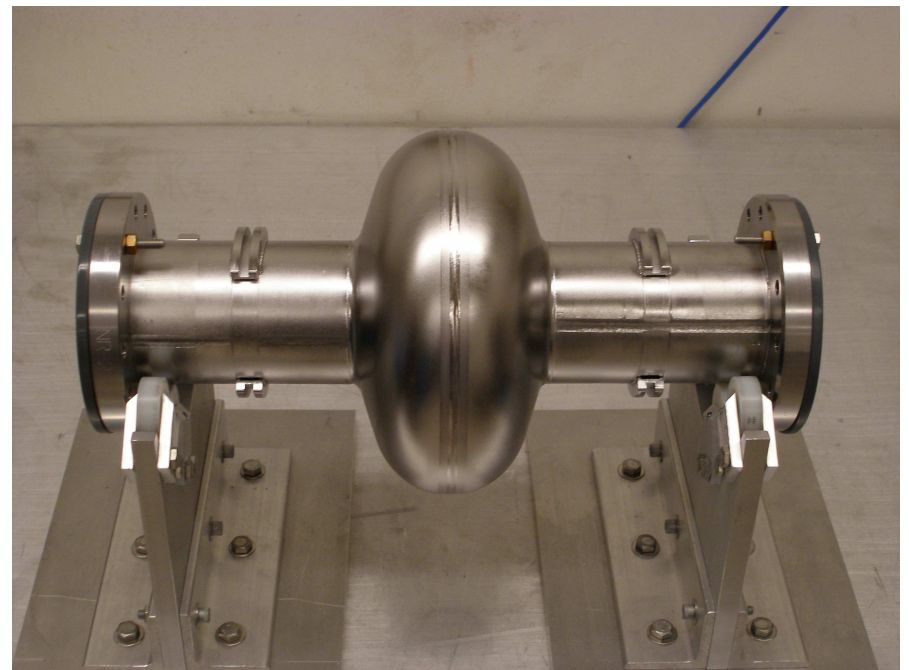
- Two cavities tested last year quenched but the defect was not located on the equator EBW or the iris.

- An additional 100 μm BCP etch of these 2 cavities “fixed” this defect.
- Equator EBW defects were then encountered which limited the maximum achievable surface fields.

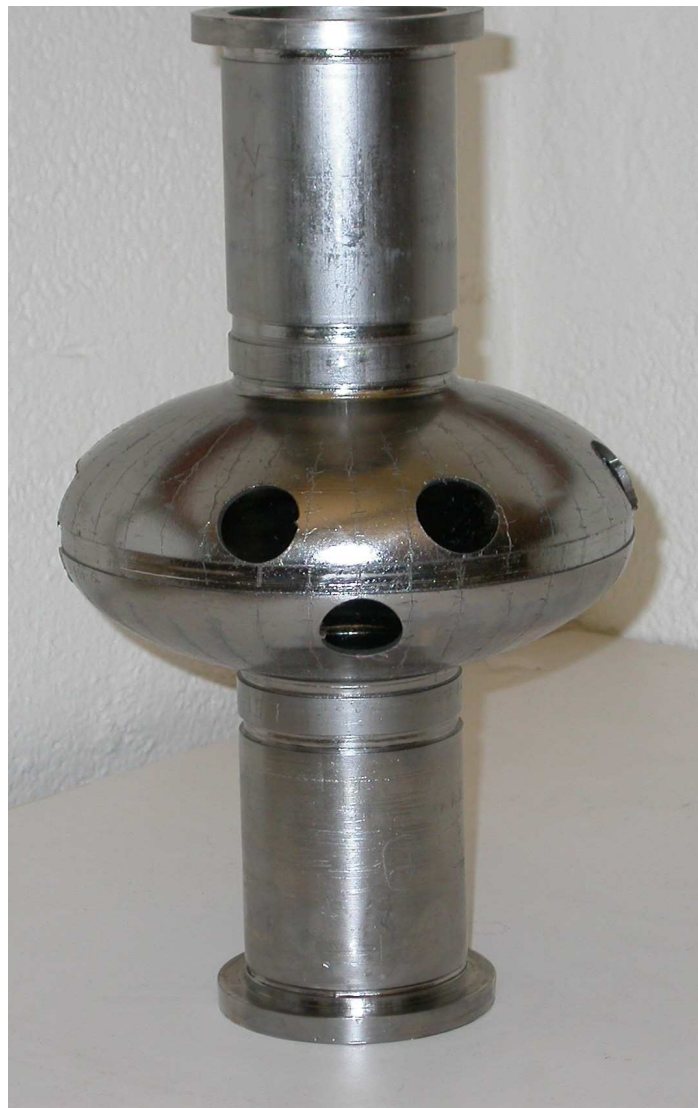
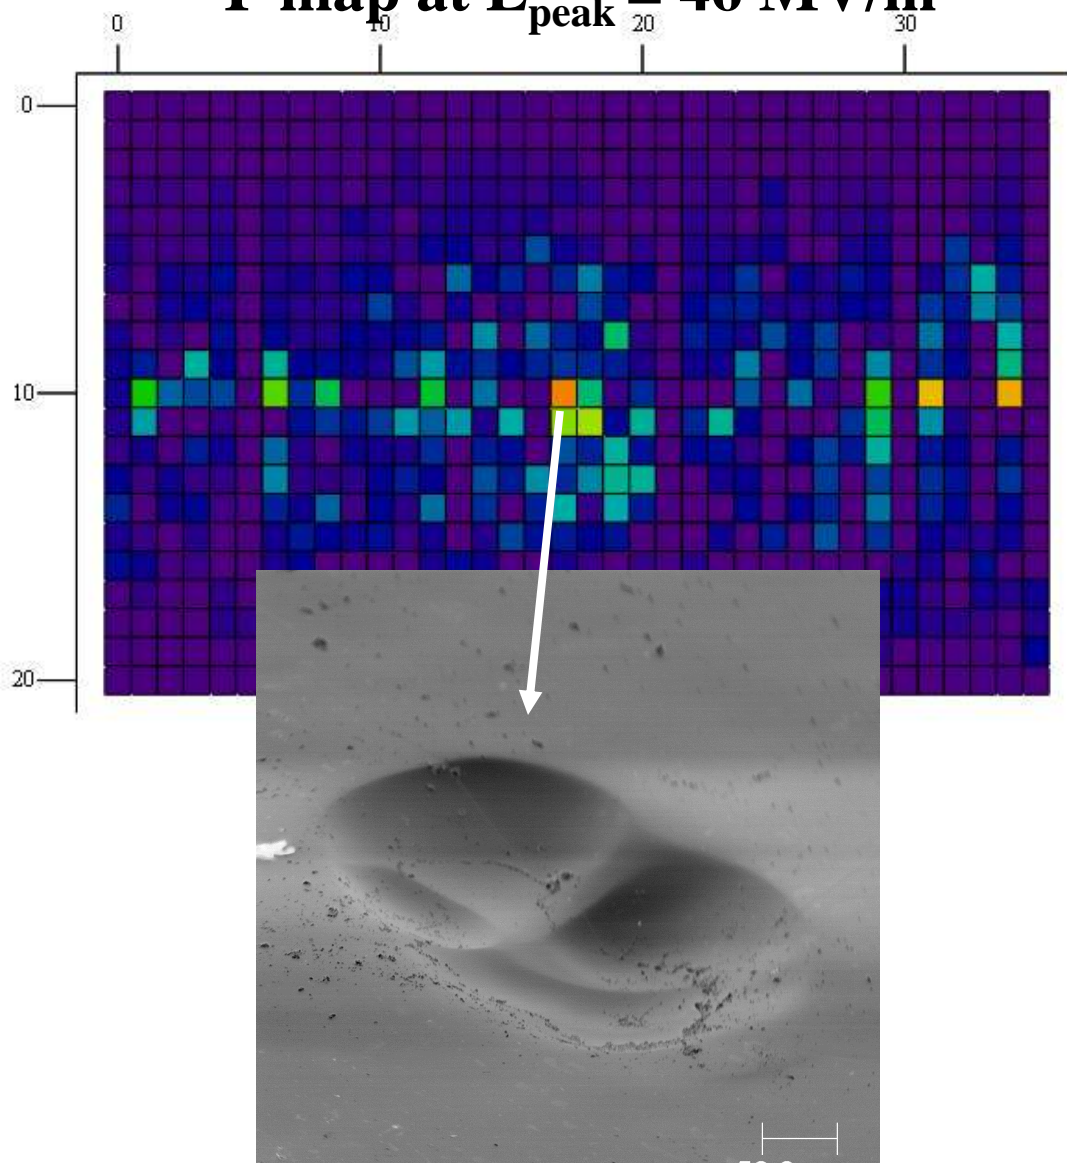
T-map at $E_{\text{peak}} = 46 \text{ MV/m}$

- Pictures of cavity defects have limited use.
- We need more information.
 - SEM
 - Measure any impurities.
 - Ect...
- For example...
